Technical Memo

To: Spruce Road Bulk Sample Site Project File - Minerals

RE: Water quality/quantity evaluation on 10/29/2010

Summary:

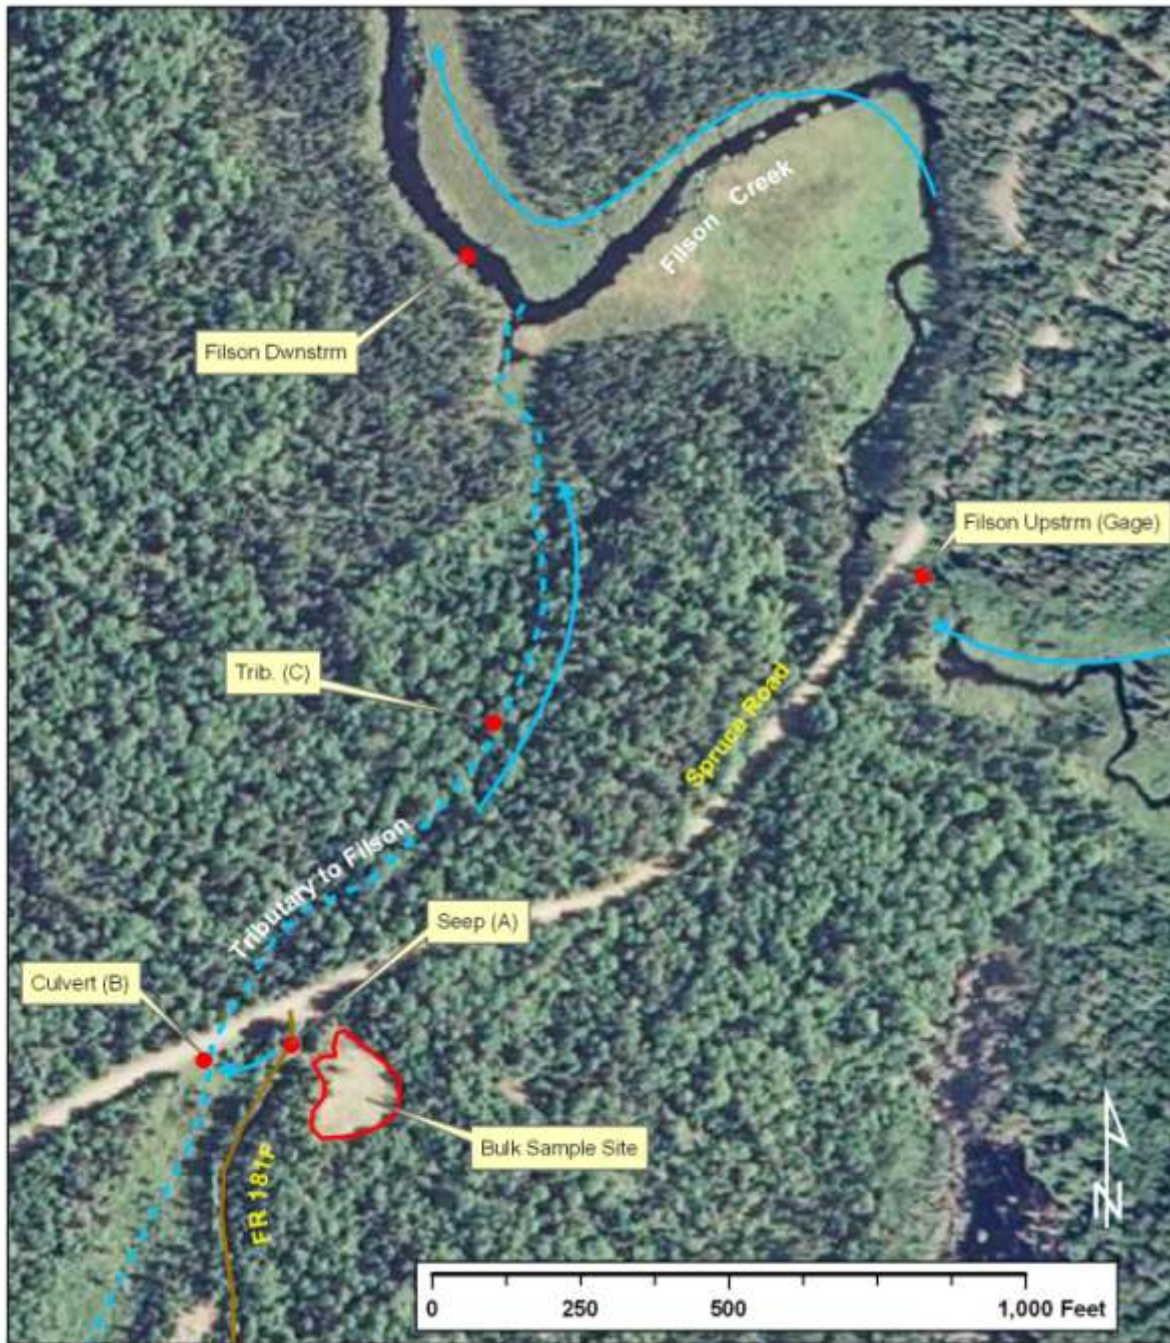
Figure 1. Map of the Spruce Road Bulk Sample Site area including water sample sites.

Samples were collected at five sites in the area on 10/29/2010 (Figure 1). This single sampling event was used as a simple status check on water quality and quantity compared to more extensive data sets and sampling regimes done in the mid 1970's. Sites corresponded to several of the sites sampled in 1975-76 (Appendix 1), including the Seep (A), Culvert (B) on the tributary receiving the seep, a downstream site on the tributary (C), and Filson Creek both upstream (Gage) and downstream (DS) from the confluence of the tributary. The current samples collected from Filson Creek upstream and downstream of the tributary confluence were closer to the confluence compared to the sites established in the 1976; however, these sites are comparable in position and characteristics to the 1976 sites.

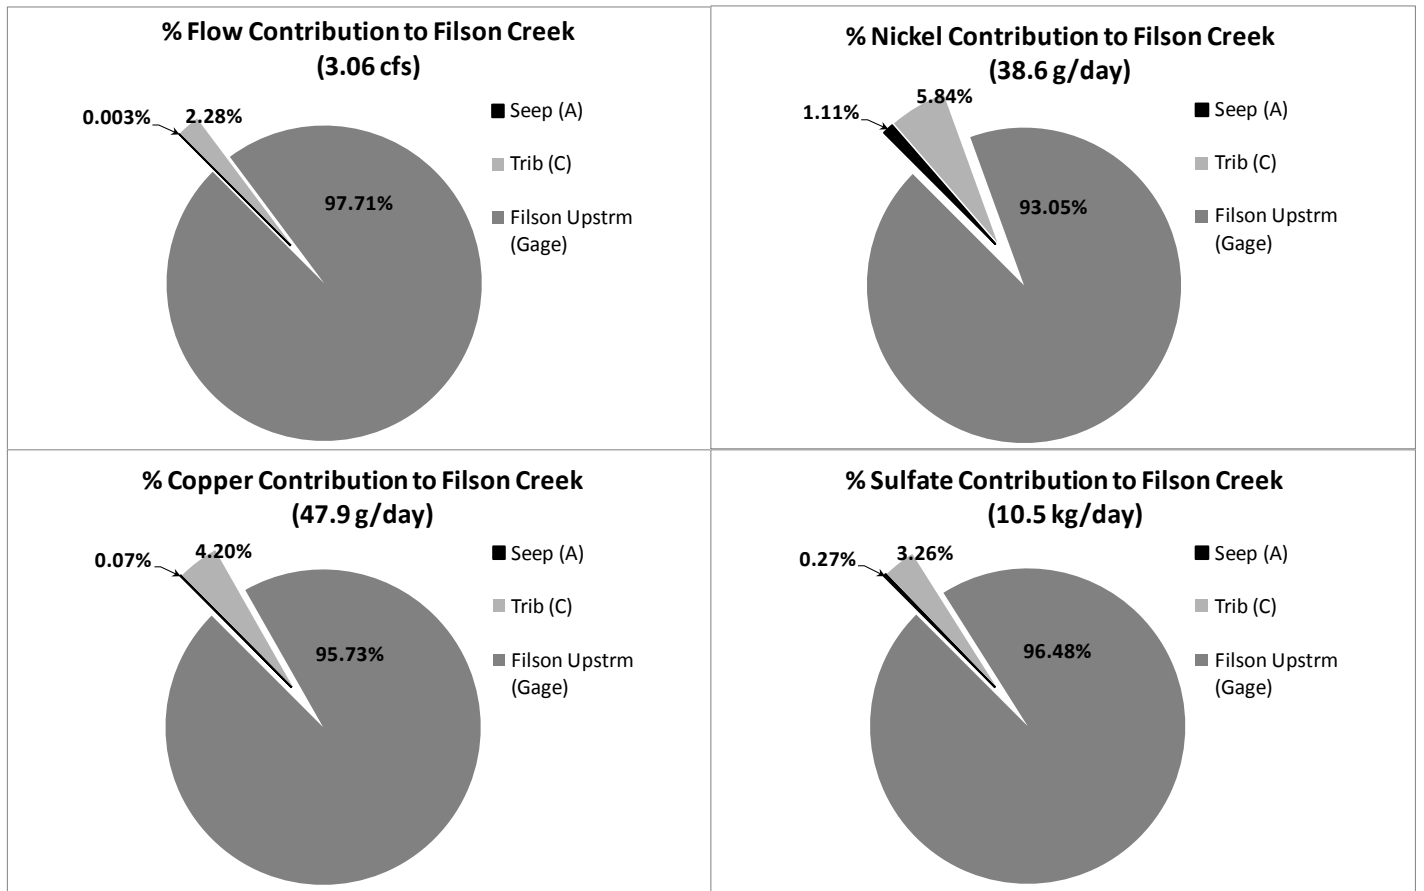
Figure 2. Percent contribution of each upstream site to Filson Creek for flow and total chemical loads. (flow and loads for Filson Creek Downstream of the Bulk Sample Site noted in parentheses)

Downstream impacts are a function of both the concentration of the constituent and the amount of flow. The product of the estimated daily discharge rate and the concentration yields the daily load. Daily load helps to provide a better understanding of relative influence in space (between sites) and time (between years). Loads for total copper and total nickel at the seep are small compared to those found in Filson creek (Table 1); the seep contributes about 0.07% of copper, 1.11% of nickel, and 0.27% of sulfate to Filson Creek (Figure 2 and Figures 6-8). Mass for these constituents does not balance to the total output at the downstream site (Figures 6-8). This is due to substantial variability in inputs and outputs of flow and concentrations throughout the watershed. In addition, variability is introduced in the form of heterogeneous geology, landform, flow, and chemical interactions relative to the small number of sites and low sample size representing the area.

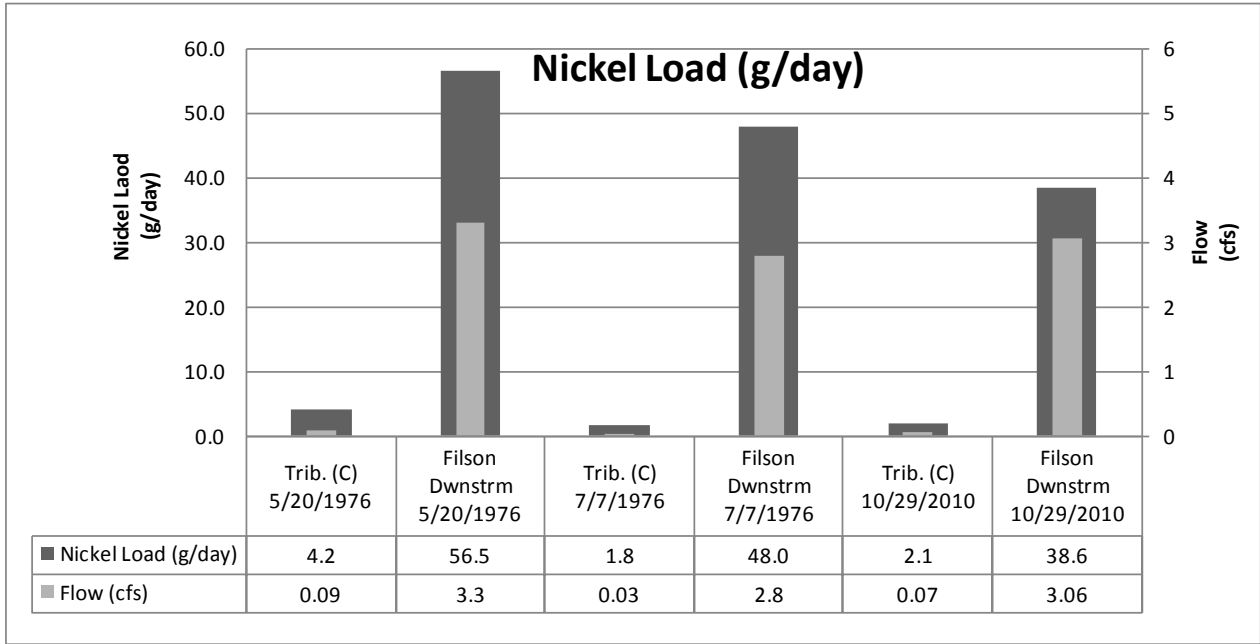
Compared to data in 1976 under similar flow conditions, loads in 2010 have not changed substantially for total copper and total nickel (Figure 3). Concentrations for chemical constituents in 2010 remain similar to levels found in 1975 when comparing sites during fall sample periods (Appendix 4). Although some constituents seem to show a trend in decreasing concentration through time, statistical significance cannot be determined due to low sample size.

Figure 3. Total copper and total nickel loading for the Tributary to Filson Creek downstream of the Bulk Sample Site and Filson Creek downstream of the Bulk Sample Site for three time periods of similar flow.

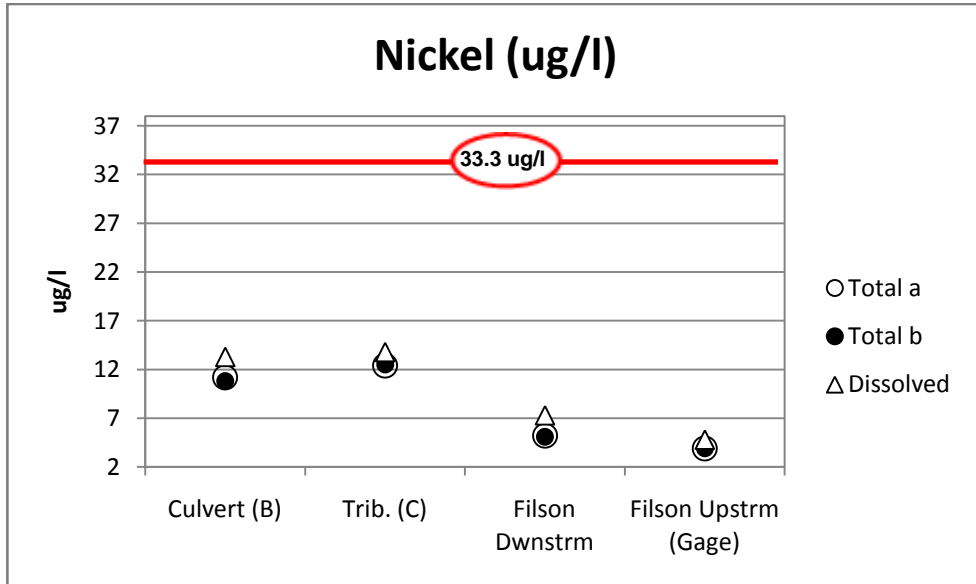
Figure 5. Nickel concentrations (ug/l) at sites near the Spruce Road Bulk Sample Site on 10-29-2010. Each symbol represents a sample point; circles represent unfiltered (total) samples and triangles represent filtered (dissolved) samples. The red line denotes the water quality standard (chronic standard, Class 2B waters of the state, aquatic life and recreation). Seep data was not plotted for scale.

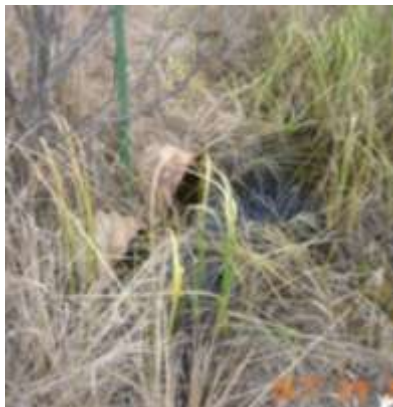
The headwater and tailwater was measured at the culverts beneath Spruce Road. The crossing consists of twin 15-inch corrugated metal pipes (cmp's) beneath the roadway. A survey of these pipes was completed on 1/31/2011. The tailwater was observed to be below the inverts of the culverts on 10/29/2010 and was therefore considered a free discharge. Photos of the upstream and downstream ends of culverts are shown below in Figures 1 and 2.

Figure 1 – Upstream End
Unnamed Trib to Filson at Spruce Rd
HW ~ 0.7 ft, but likely clogged

The headwater was measured to be 0.7 ft at the culverts (see Attachment A). The *computed* discharge rate for this condition is 1.7 cfs (see Attachment B). However, as shown in Figure 3 the observed flow is much less than 1.7 cfs. Some flow could be undermining the culvert outlet if the culvert has failed under the embankment. However, there was no observed failure and the observed flow downstream of the crossing remained much less than 1.7 cfs. Observation of flow conditions on 10/29/2010 at the confluence between the Tributary and Filson Creek confirms that the flow in the Tributary was not close to half of the flow in Filson Creek (estimated to be 2.99 cfs – see below). As a matter of comparison, the contributing watershed area for Fison Creek is approximately 35 times larger than the contributing drainage area for the Tributary. Hence, it is considered that there was internal blockage of the culvert that raised the headwater of the culvert. Observation of the upstream end of the culverts (see Figure 1) confirm the potential for blockage within the culvert. Thus, based upon these considerations the *computed* discharge rate based upon the measured culvert headwater is *rejected*.

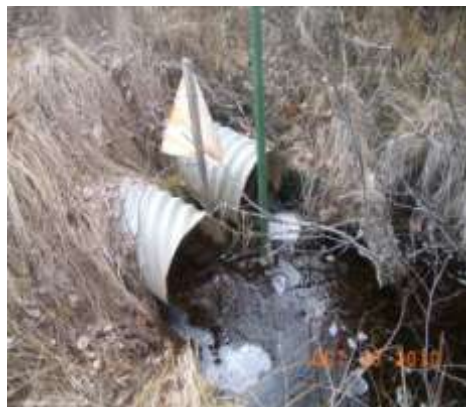
Figure 2 – Downstream End
Unnamed Trib to Filson at Spruce Rd
Note: free discharge and magnitude of
discharge << 1 cfs

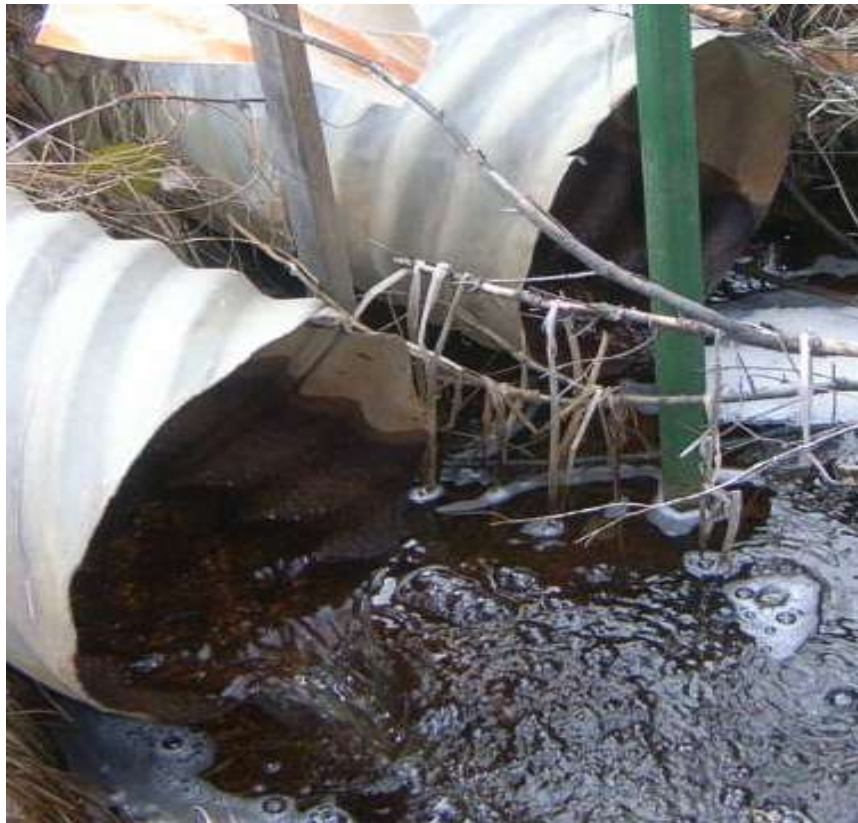
Figure 3. Exploded view of downstream end of Spruce Road culverts

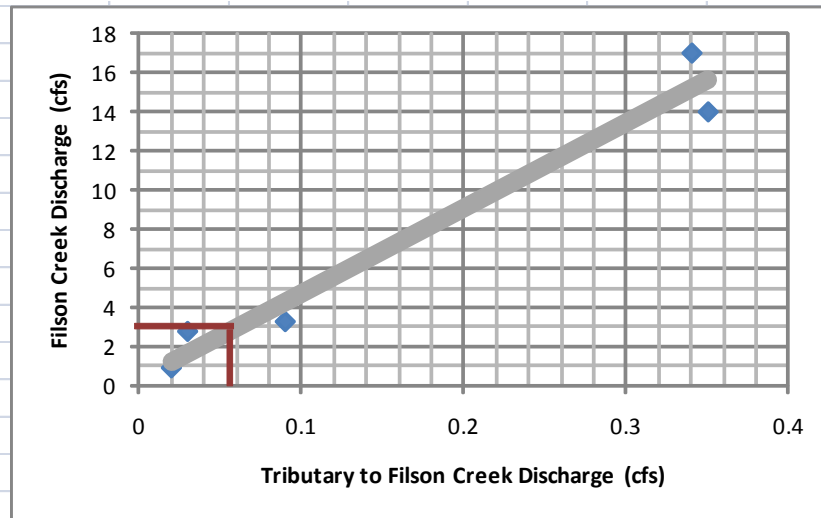
Figure C-3: Filson / Tributary Flow Ratios
 Linear Trend Line developed using only $Q_{\text{Filson}} \leq 17$ cfs
Based upon this analysis $Q_{\text{Tributary}} = 0.06$ cfs at $Q_{\text{Filson}} = 2.99$ cfs

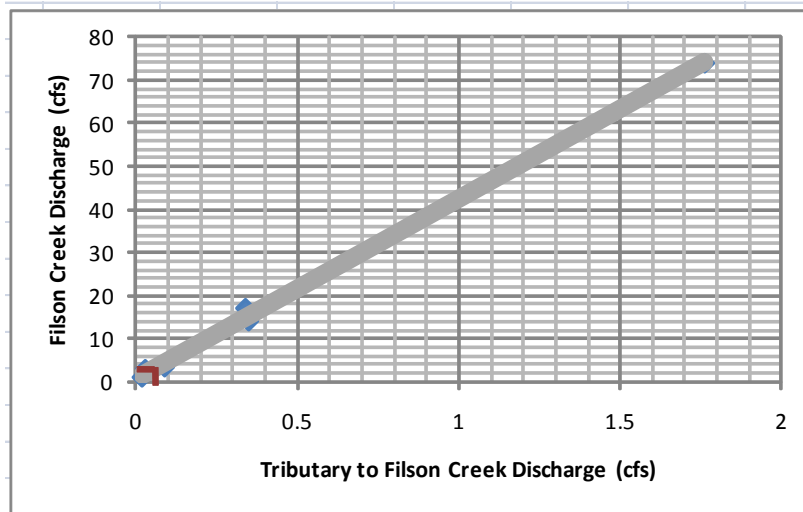
Figure C-4: Filson / Tributary Flow Ratios
 Linear Trend Line developed using all 1976 data
Based upon this analysis $Q_{\text{Tributary}} = 0.05$ cfs at $Q_{\text{Filson}} = 2.99$ cfs

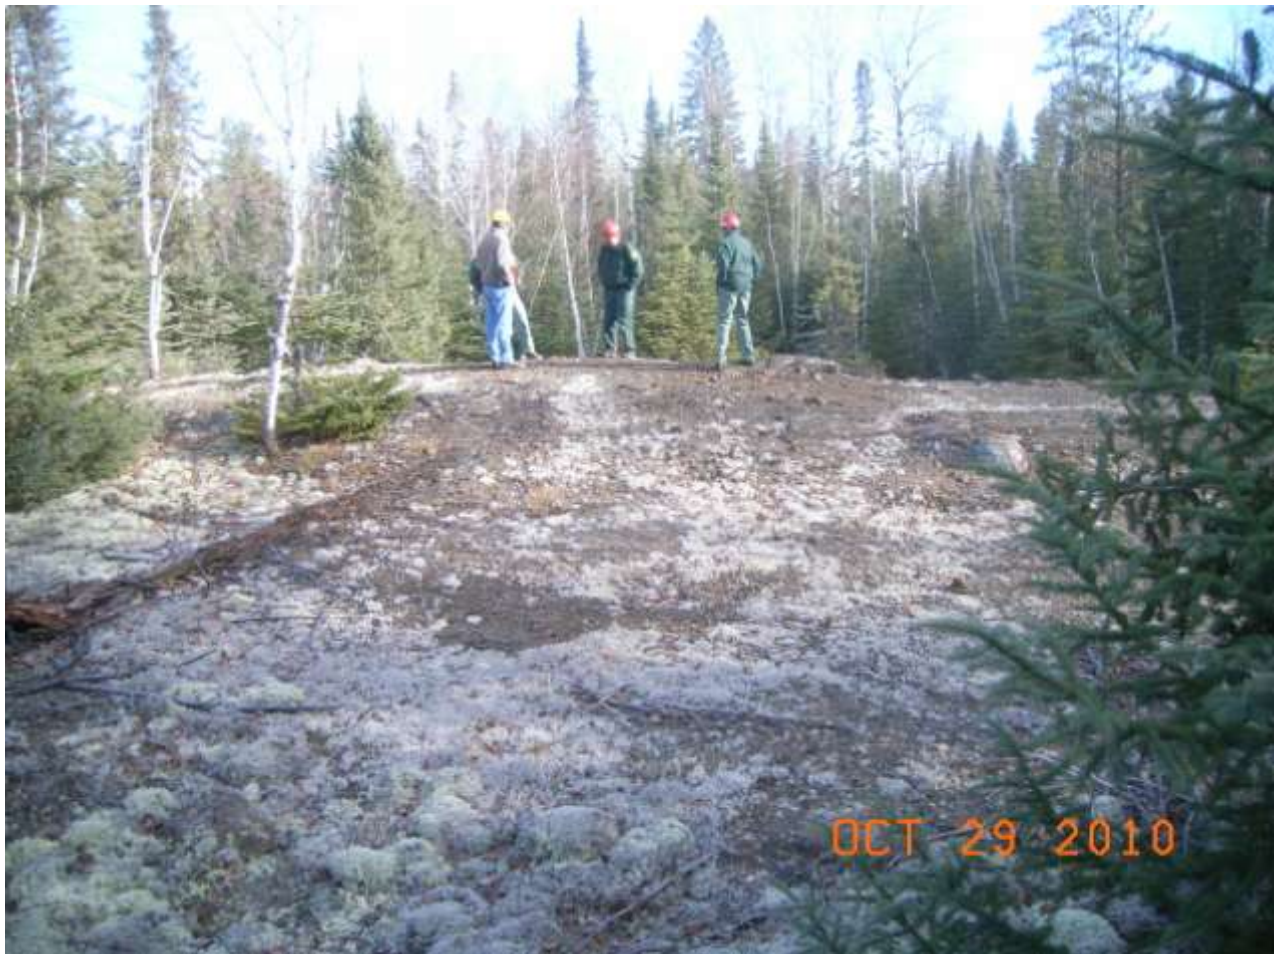
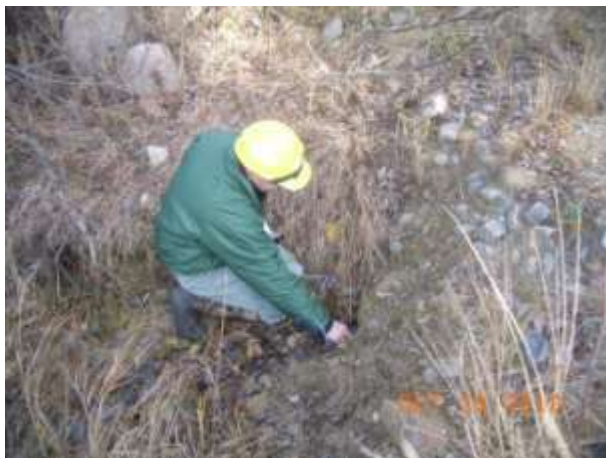
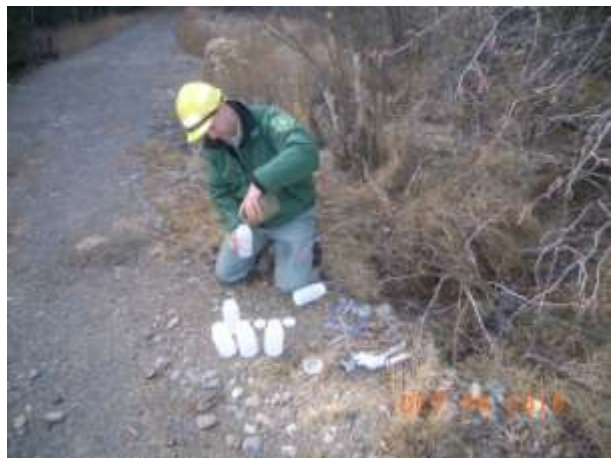
Above: Top of Bulk Sample Site;

Below: Collecting water samples at the seep outlet with a hand pump (Left) and sample bottles (Righth).

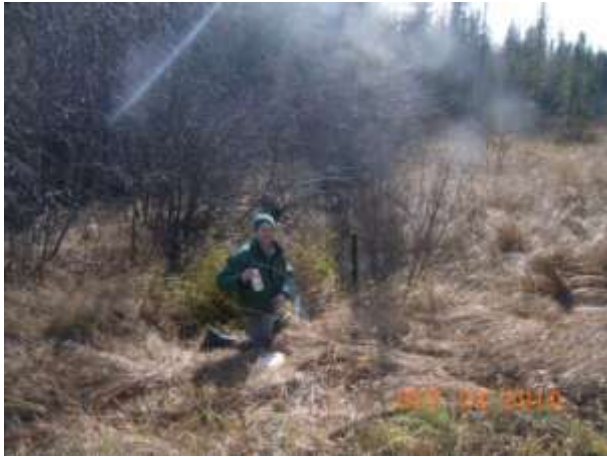
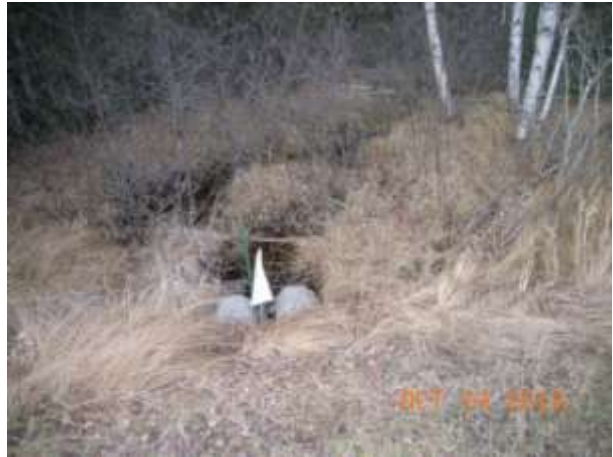
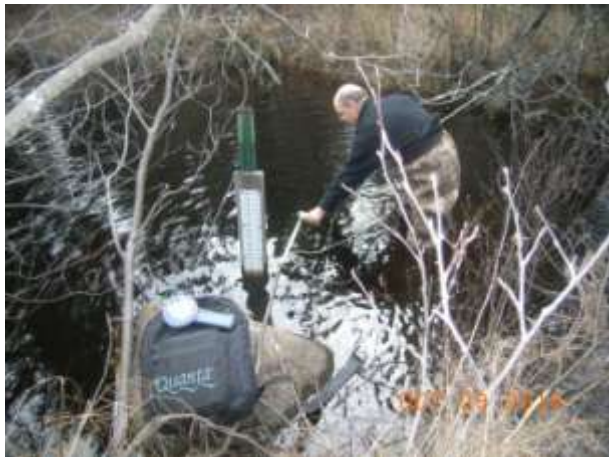
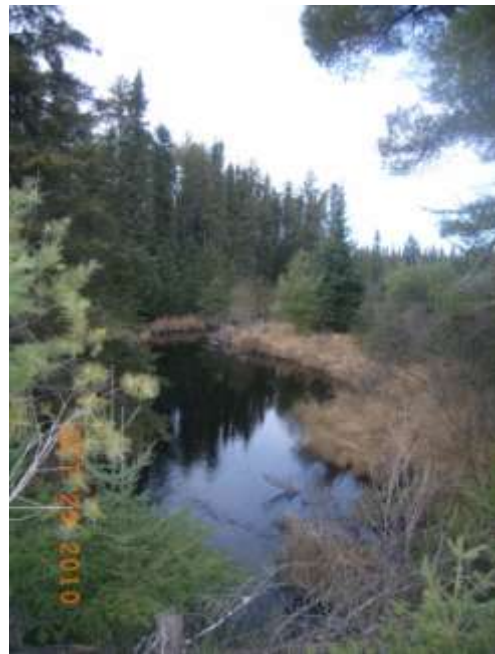
Above, Left: Upstream of Culvert crossing on tributary to Filson Creek below the seep;
Above, Right; Downstream of crossing on tributary to Filson Creek below the seep

Below, Left; Filson Creek upstream of Spruce Road at Gage site.
Below, Right; Filson Creek downstream of Spruce Road at Gage site.
